# TREE REPORT

***Land North of  
THE KILNS  
Llangwm  
Haverfordwest  
SA62 4HG***

***Pre – Development BS5837  
TREE SURVEY***

***July 2021***

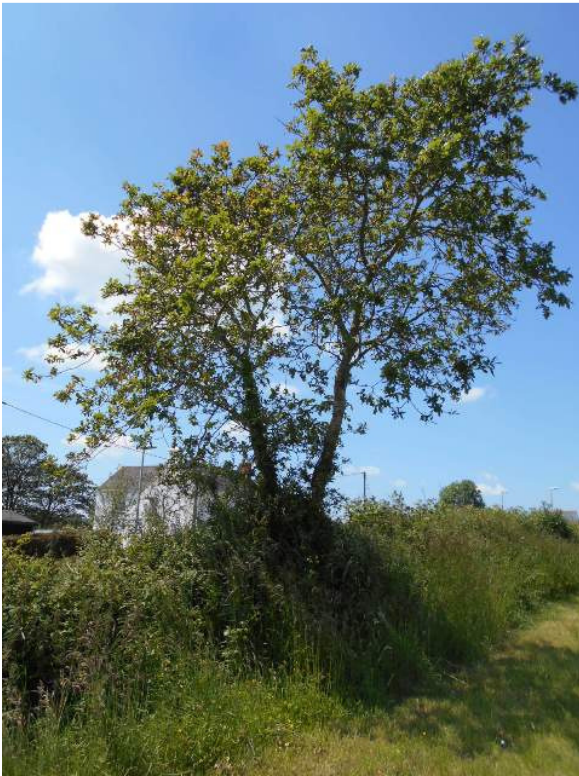
T1 – View of twin stem and location in hedge 1

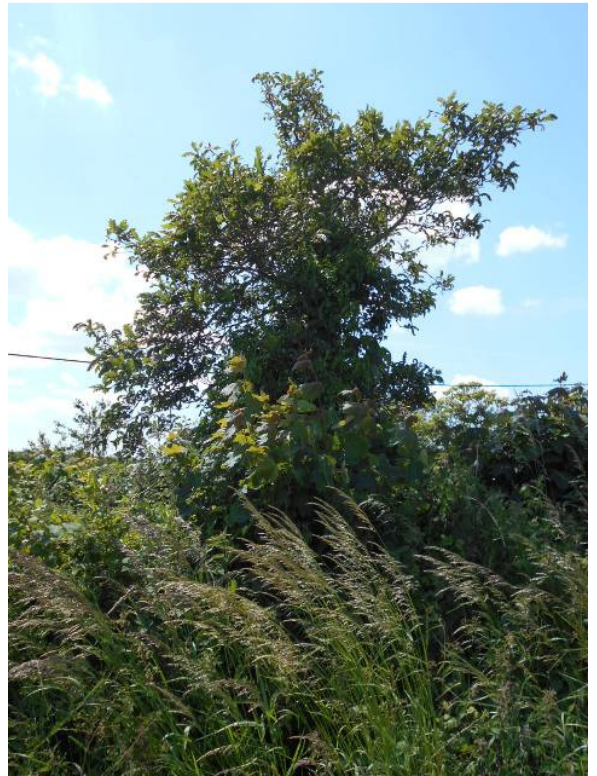
2	Oak	4	100	2.0	Y	2.0	1.0	2.0	1.0	GOOD	<ul style="list-style-type: none"> <li>Dense Ivy growth to upper crown</li> <li>Young tree located in H1</li> <li>No other visible external defects</li> </ul>	No works required	20	<b>B1</b>	1.2
3	Oak	10	420 @ 1m	3.0	M	3.0	4.0	4.0	4.0	FAIR	<ul style="list-style-type: none"> <li>Has been topped off at 1.2m long ago</li> <li>Multi-stemmed re-growth x 8</li> <li>Minor Ash Dieback symptoms throughout crown</li> <li>Located on boundary of neighbouring garden, South crown overhangs roof</li> <li>No other visible external defects</li> </ul>	No works required	10	<b>C1</b>	5.0

T2 – View of Ivy growth on trunk and location in hedge 1

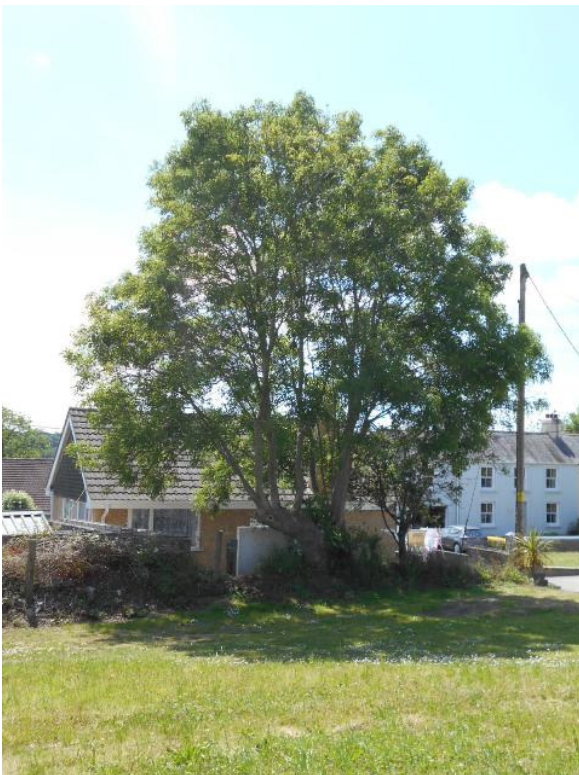
T3 – View of multi-stem upright nature of crown

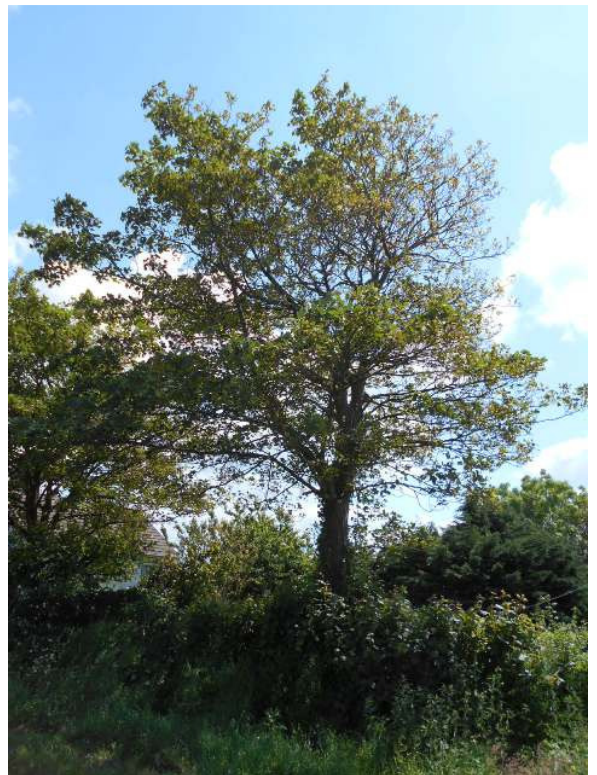
Tree Tag No.	Species	Height (m)	Calculated Stem diameter (mm)	Height crown clearance/ (m)	Age Class	Branch spread (m)				Vitality	Structural condition notes	Recommended Works	Est remain years	Category grading	RPA radius (m)
						N	S	E	W						
4	Sycamore	4	310	4.0	Mi	5.0	3.0	4.0	4.0	FAIR	<ul style="list-style-type: none"> <li>Upper and mid-crown South and South West have sparse small leaved yellow coloured foliage cover</li> <li>Remainder of foliage also small</li> <li>No obvious cause</li> <li>Has been crown lifted to 4m</li> <li>Located on boundary of site in H2</li> <li>No other visible external defects</li> </ul>	No works required	10 to 20	C1	3.7
5	Sycamore	10	360	4.0	Mi	5.0	4.0	5.0	5.0	GOOD	<ul style="list-style-type: none"> <li>Located on boundary of site in H2</li> <li>Minor dieback to upper and mid crown South</li> <li>Lower crown North pruned back and crown lifted to 4m</li> <li>Neighbouring garage at 0.5m to South</li> <li>No other visible external defects</li> </ul>	No works required	20 to 40	C1	4.3

T4 – View of foliage loss and dieback to West half of crown

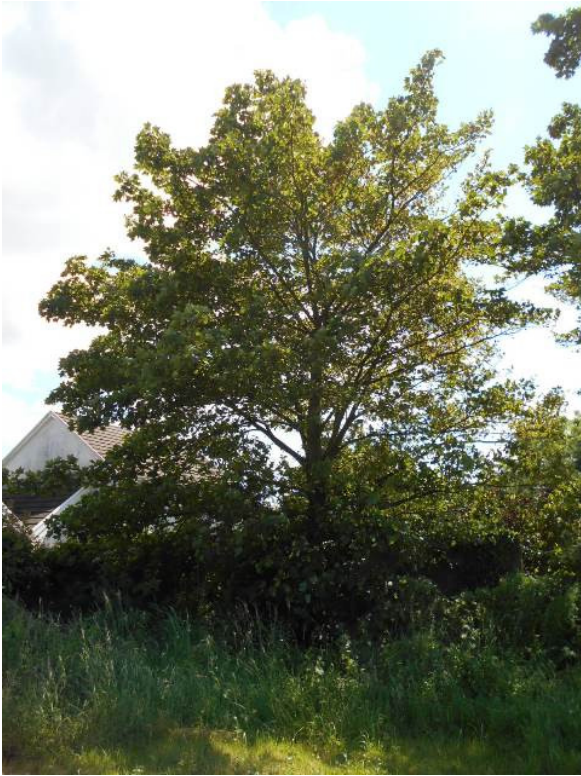
T5 – View of good upright form and location in hedge 2

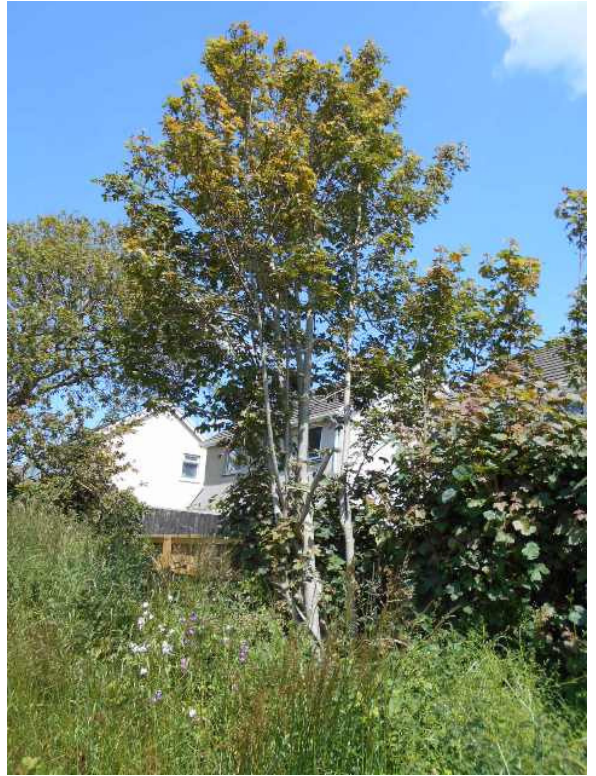
T6 – View of multi-stem upright nature of crown

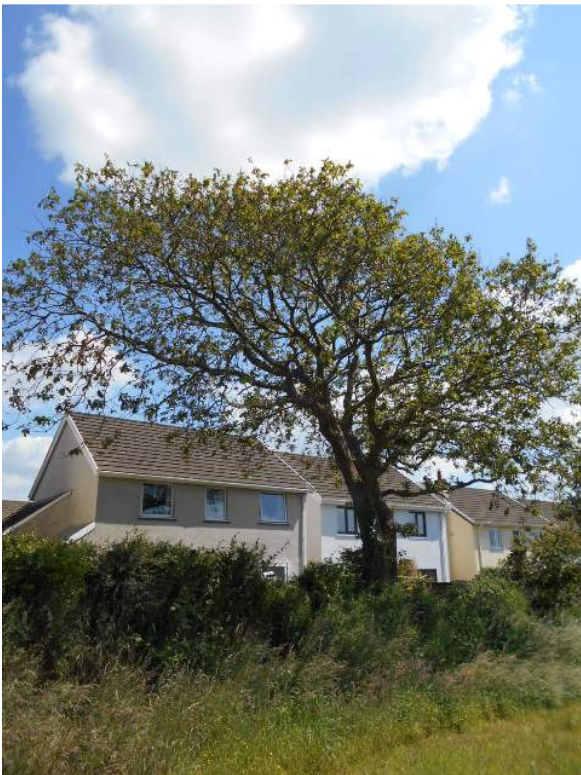
T7 – View of broad dome shaped crown

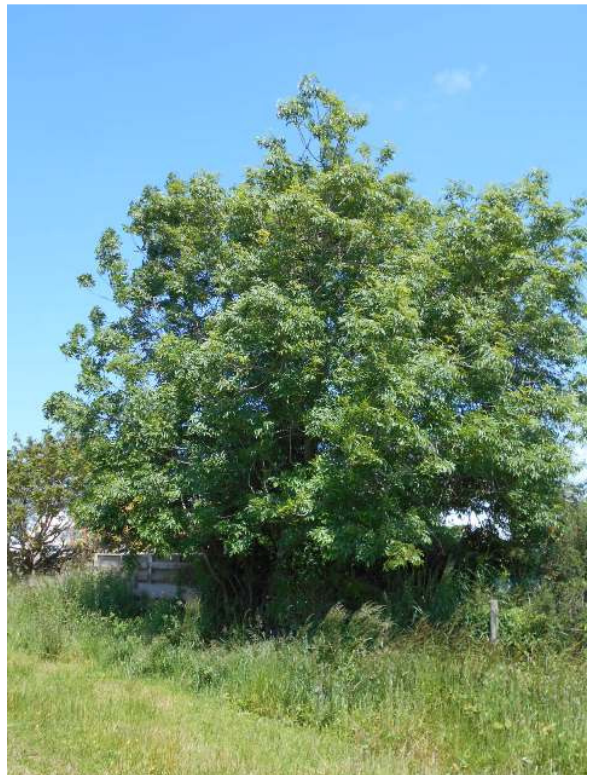
Tree Tag No.	Species	Height (m)	Calculated Stem diameter (mm)	Height crown clearance/ (m)	Age Class	Branch spread (m)				Vitality	Structural condition notes	Recommended Works	Est remain years	Category grading	RPA radius (m)
						N	S	E	W						
8	Ash	12	400 @ 1m	2.0	M	4.0	5.0	4.0	4.0	GOOD	<ul style="list-style-type: none"> <li>• Appears to be an old laid hedgerow tree with extensive upright re-growth from 1.2m, located on boundary</li> <li>• Multi-stemmed x 10</li> <li>• No Ash Dieback symptoms in crown</li> <li>• No other visible external defects</li> </ul>	No works required	20	B1	4.8
9	Oak	5	320 (est)	1.0	Y Mi	3.0	3.0	4.0	4.0	FAIR	<ul style="list-style-type: none"> <li>• Located just over boundary of site in corner of adjacent garden</li> <li>• Low broad dome shaped crown</li> <li>• Half of crown extends into site</li> <li>• Branch / trunk union at 1.2m with tight forks with included bark</li> <li>• No other visible external defects</li> </ul>	No works required	20	C1	3.8

T8 – View of wide spreading crown

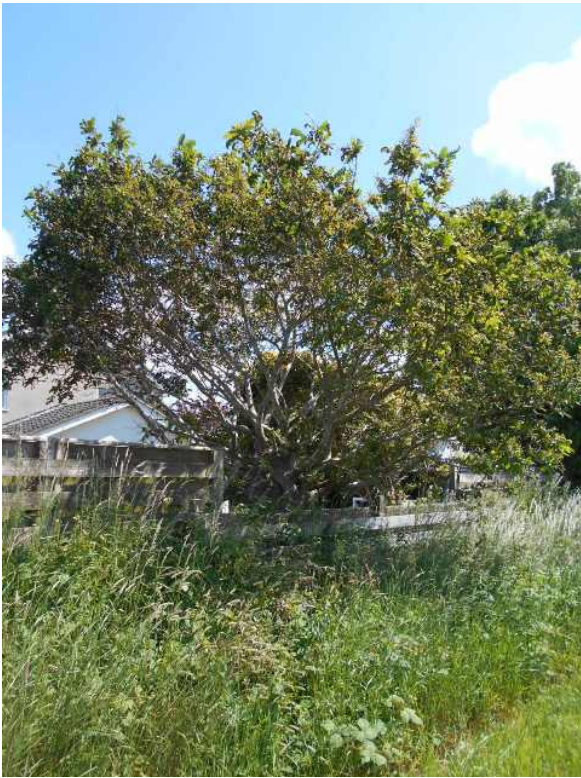
T9 – View of low dome shaped crown and location just over site boundary in corner of neighbouring garden

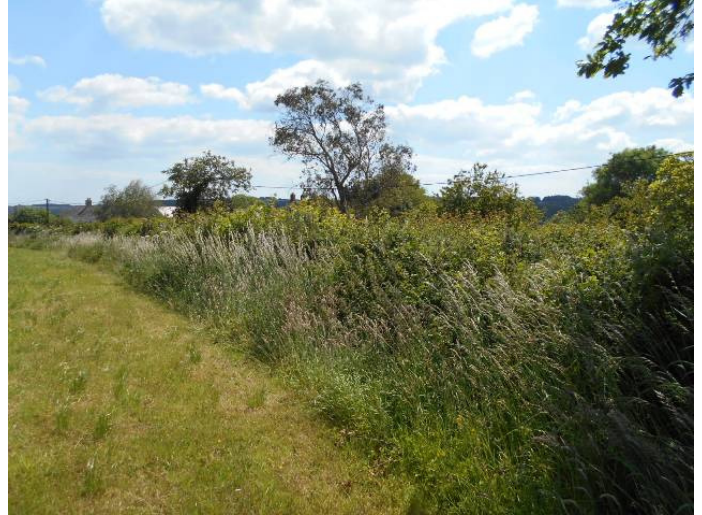
H1 – View of

Tree Tag No.	Species	Height (m)	Calculated Stem diameter (mm)	Height crown clearance / (m)	Age Class	Branch spread (m)				Vitality	Structural condition notes	Recommended Works	Est remain years	Category grading	RPA radius (m)
						N	S	E	W						
H1	Ash Hawthorn Hazel Holly Sycamore Blackthorn Elder	1.2 (av)	90 (av)	0.0	M	2.0	2.0	2.0	2.0	FAIR	<ul style="list-style-type: none"> <li>Field boundary hedgerow</li> <li>Trimmed into a square shape</li> <li>Dense Bramble growth along base and throughout hedge</li> <li>No other visible external defects</li> </ul>	No works required	20	<b>B2</b>	3.6
1	Oak	6	E-160 W-150	E-4.0 W-3.0	Y	4.0	4.0	4.0	3.0	GOOD	<ul style="list-style-type: none"> <li>Twin stemmed co-dominant from 0.3m</li> <li>Located in H1</li> <li>Old barbed wire embedded in trunk</li> <li>Minor Ivy growth on trunk</li> <li>Has been crown lifted over field</li> <li>Minor surface wounds to upper trunk most likely from hedge trimming</li> <li>No other visible external defects</li> </ul>	No works required	20 to 40	<b>B1</b>	2.6

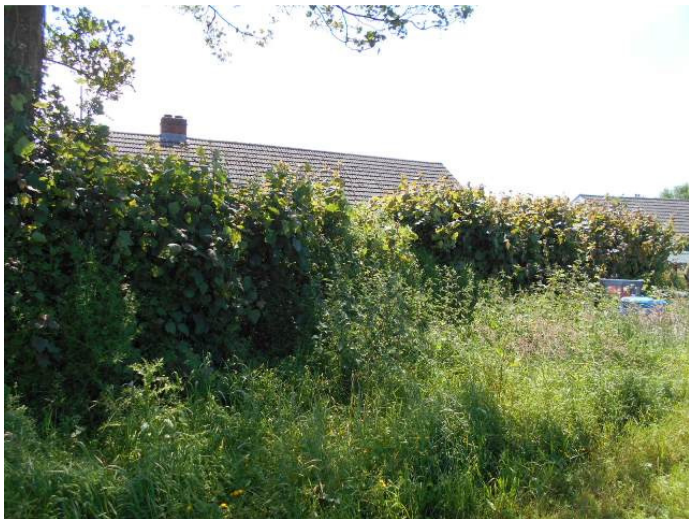
H2 – View of

H2	Sycamore	2	70 (av)	0.0	M	1.0	1.0	1.0	1.0	GOOD	<ul style="list-style-type: none"> <li>Regularly trimmed as a square shape</li> <li>Dense foliage cover – provides good screening along boundary</li> <li>No other visible external defects</li> </ul>	No works required	10	C2	3.6
6	Sycamore	8	120 (av)	3.0	Mi	1.0	2.0	2.0	1.0	FAIR	<ul style="list-style-type: none"> <li>Multi-stemmed x 5</li> <li>Upright crown and branch structure</li> <li>Located at North end of H2</li> <li>Lower crown E &amp; W pruned back</li> <li>No other visible external defects</li> </ul>	No works required	10	C1	3.8
7	Oak	10	500	4.0	Mi	6.0	6.0	5.0	5.0	FAIR	<ul style="list-style-type: none"> <li>Minor dieback throughout crown</li> <li>Epicormic shoots on main limbs</li> <li>Has been crown lifted to 4m</li> <li>Medium dead wood in inner crown</li> <li>Located on fence line of adj. garden</li> <li>No other visible external defects</li> </ul>	No works required	20	B1	6.0

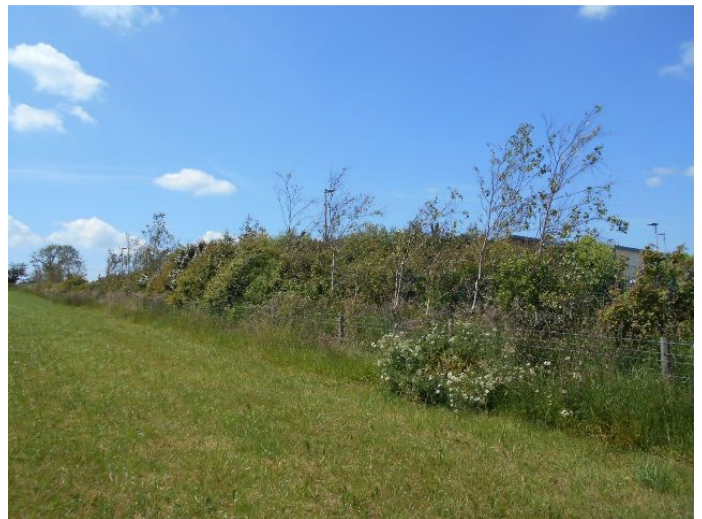
H3	Silver Birch Hawthorn Eleagnus Hazel Viburnum Privet Beech Oak	2 to 6	50 (av)	0.0	Y	1.0	1.0	1.0	1.0	FAIR / POOR	<ul style="list-style-type: none"> <li>• Gappy, intermittent new planting between field boundary fence and adjacent school boundary fence</li> <li>• Scattered individual young Silver Birch trees along length of hedge</li> <li>• Dense Bramble growth in places</li> <li>• Planted on low raised bank</li> <li>• West end alongside car park has been regularly trimmed</li> <li>• Provides screening between school and site</li> <li>• No other visible external defects</li> </ul>	No works required	10	C2	3.6
H4	Ash Hawthorn Hazel Holly Sycamore Blackthorn Elder	1.2	90 (av)	0.0	M	2.0	2.0	2.0	2.0	FAIR	<ul style="list-style-type: none"> <li>• Field boundary hedgerow</li> <li>• Trimmed into a square shape</li> <li>• Dense Bramble growth along base and throughout hedge</li> <li>• No other visible external defects</li> </ul>	No works required	20	B2	3.6

H3 – View of young hedge between two boundary fences with individual trees scattered along its length

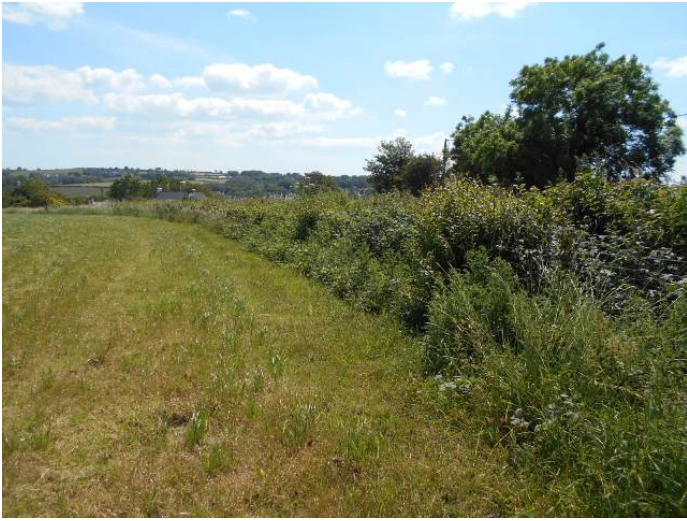
H4 – View of low square shape of boundary hedge

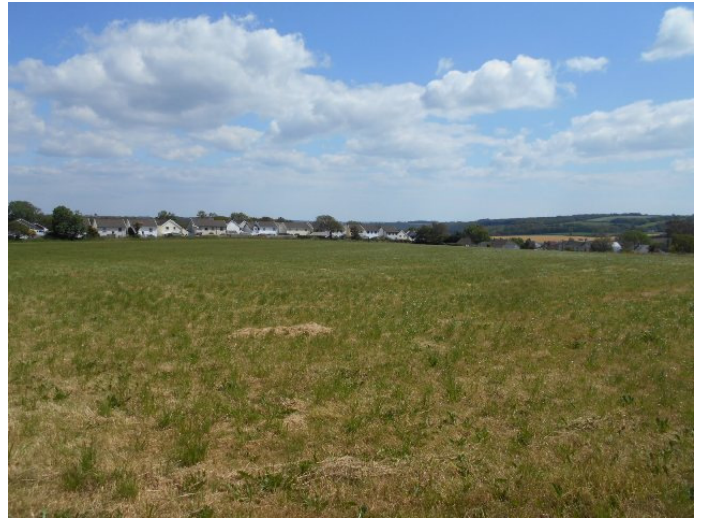
View towards SE corner of site showing location of trees 3, 4, 5, 7 and 8 around edges of site

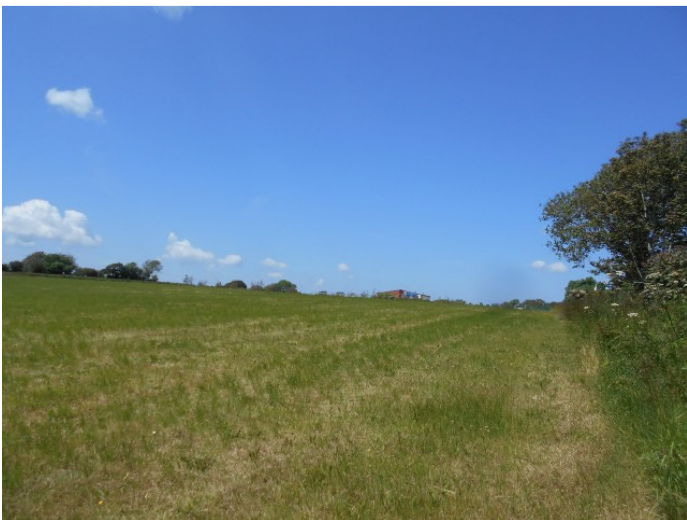
View Northwards from SE corner of site showing minimal overhang into site from tree 7
