Landscape Character and Visual Impact Assessment of Proposed Expansion of Rowston Holiday Park, New Hedges

Text, Plans, Photographs & Appendices

Prepared for Hean Castle Estates February 2020

TDA/2693/LC&VIA/RhC/07.22

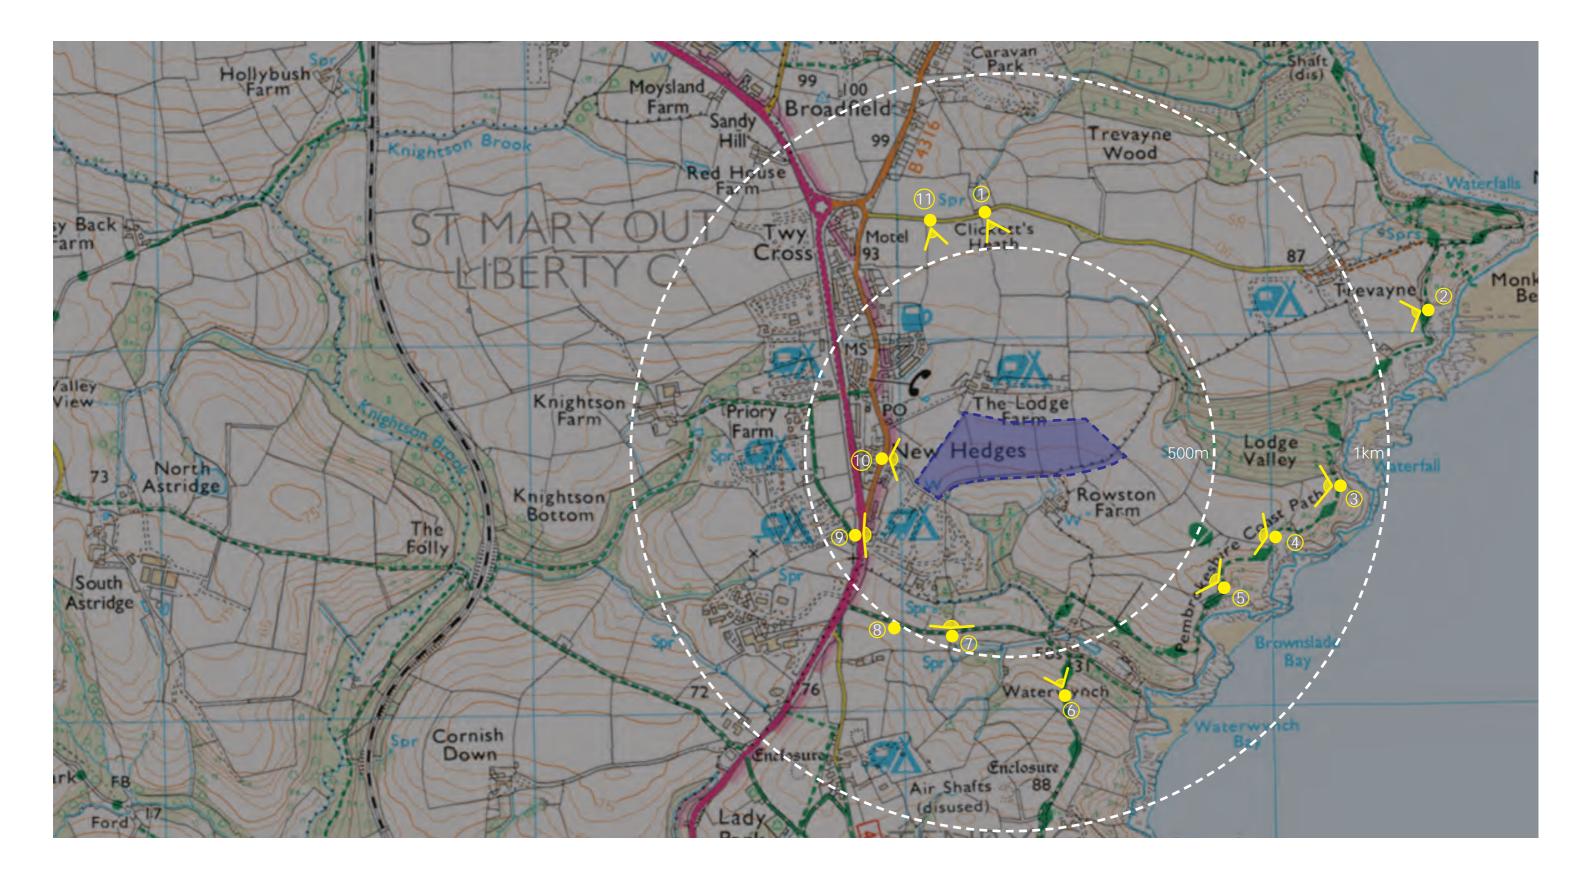
Proposed Photo Viewpoints

- 5.8 Photo viewpoints 1-11 below can be found in the Photographs section of this document. Their locations and view angles are illustrated by TDA drawing no. TDA/2536/01 - Location of Photo Viewpoints, located in the Plans section of this document.

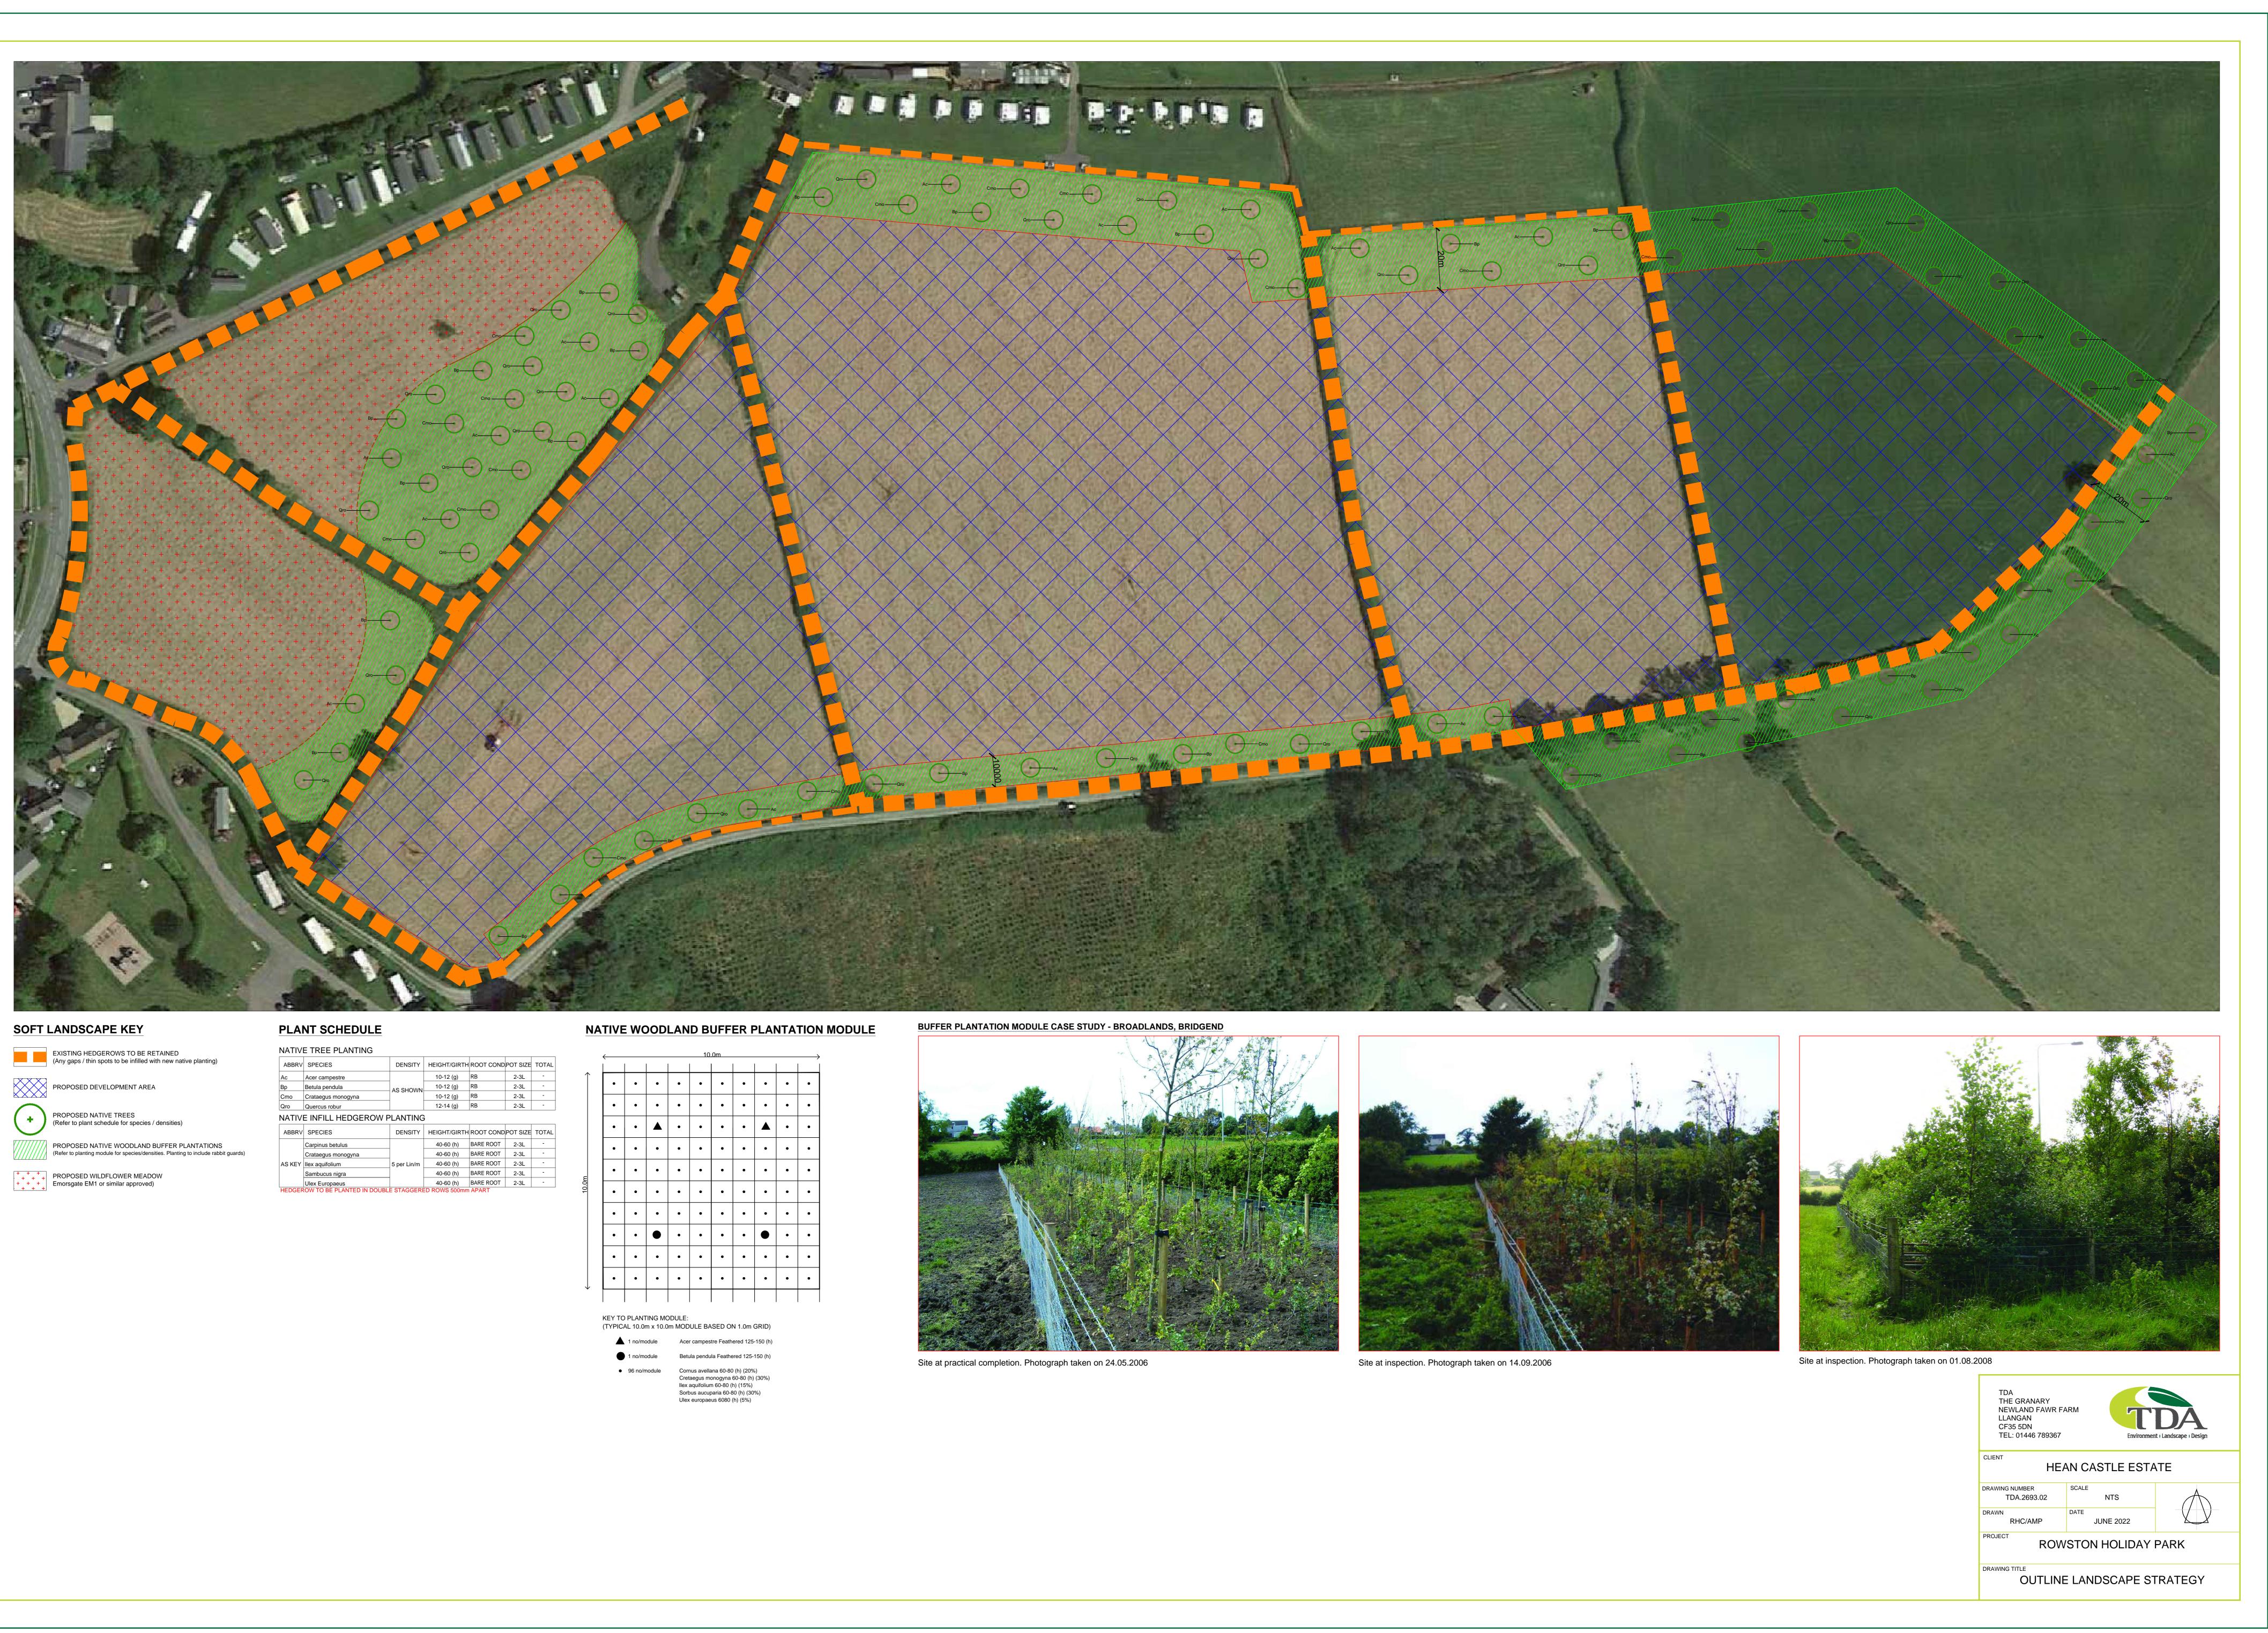
- 4.1 Landscape mitigation and enhancement proposals have been developed to sensitively integrate the development into the landscape. The proposals are illustrated by TDA drawing no. TDA.2693.02 and is in the Plans section of this document. proposals include:

- The retention of all existing field boundary hedgerows and associated hedgerow trees.
  - The infilling of any gaps / thin spots within existing hedgerows to ensure their long-term preservation, in keeping with recommendations made by the Pembrokeshire Coast National Park Landscape Character Assessment.

- A new woodland area to the western boundary of the site to improve biodiversity and ecological value, in keeping with recommendations made by the Pembrokeshire Coast National Park Landscape Character Assessment.

- A new native buffer plantation to the northern, eastern and southern boundaries to screen the development. The plantation will include understorey species and standard native trees.

5.25 The Outline Structural Landscape Strategy (TDA/2654/02) has been carefully developed to reduce the development's visual and landscape character impacts whilst improving the arboricultural/landscape value of the site.

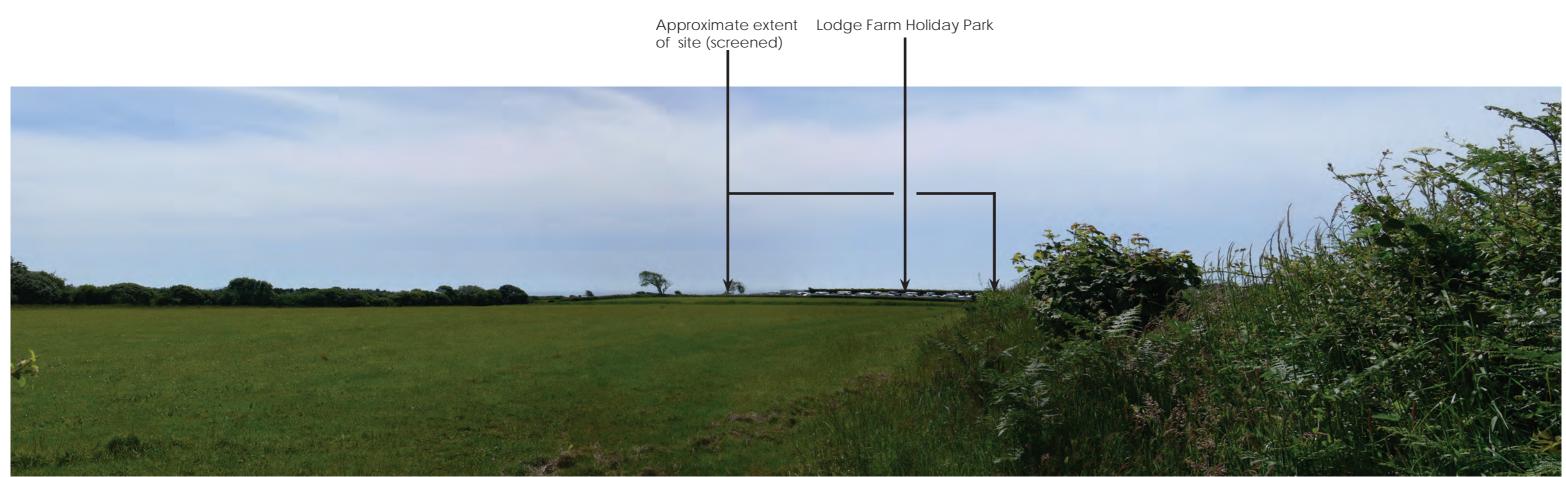
Photo Viewpoint 1: Mid-range view looking south west from the unnamed road to Trevayne camp-site

- 5.9 Photo Viewpoint 1 is a mid-range view looking south west from the unnamed road to Trevayne Campsite. The site is screened by field boundary hedgerows. Developments visual impact: no change.

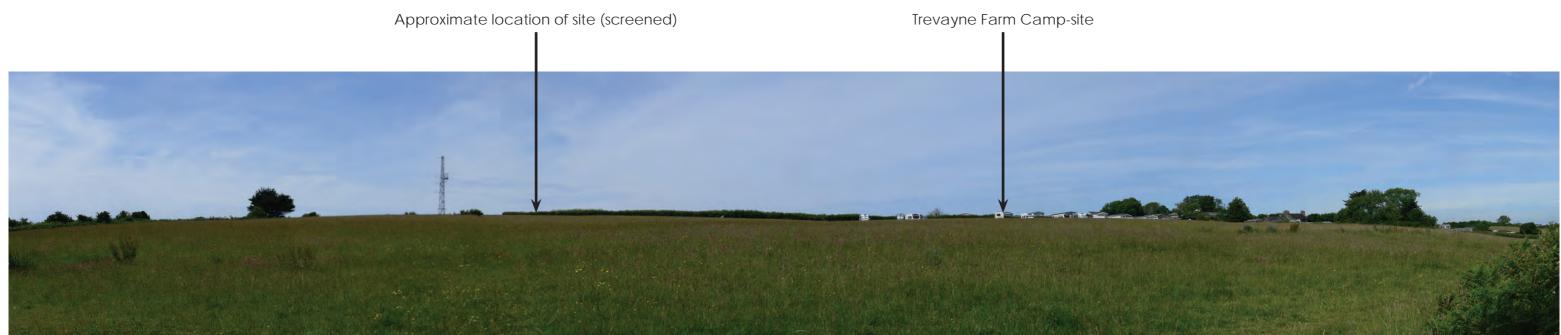
Photo Viewpoint 2: Long-range view looking south west from the Pembrokeshire Coast Path above Monkstone Beach

- 5.10 Photo Viewpoint 2 is a long-range view looking south west from the Pembrokeshire Coast Path above Monkstone Beach. The site is screened by intervening topography. Developments visual impact: no change

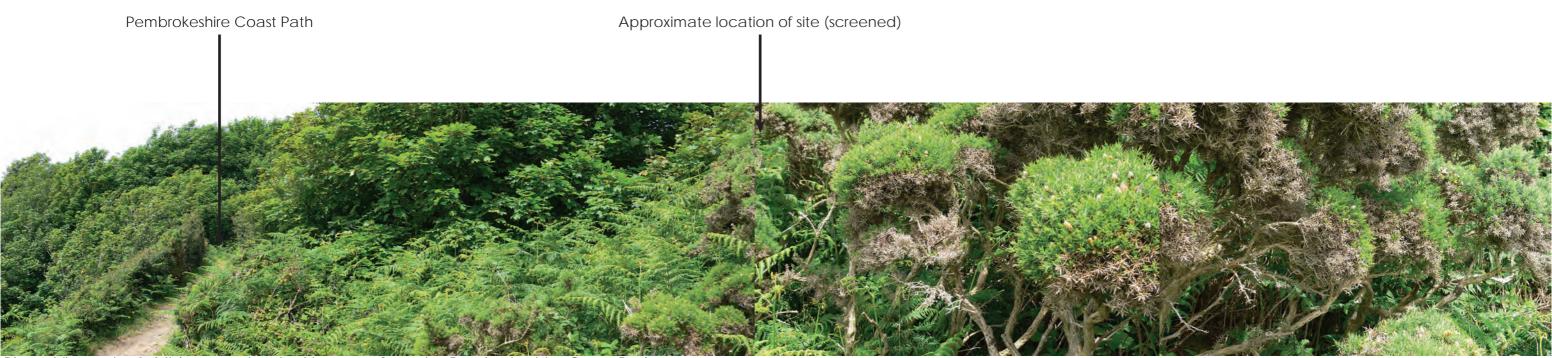
Photo Viewpoint 3: Mid-range view looking west from the Pembrokeshire Coast Path

- 5.11 Photo Viewpoint 3 is a mid-range view looking west from the Pembrokeshire Coast Path. The site is screened by intervening topography. Developments visual impact: no change

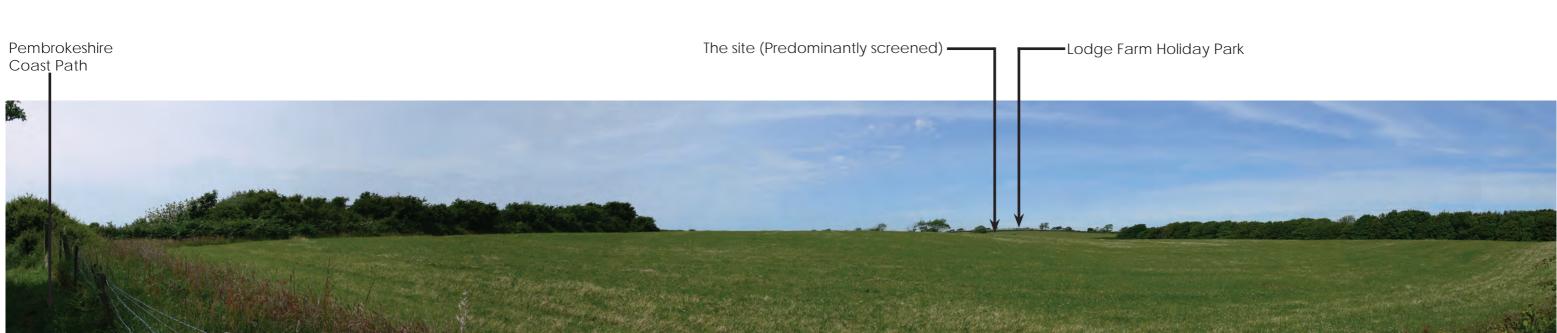
Photo Viewpoint 4: Mid-range view looking west from the Pembrokeshire Coast Path

- 5.12 Photo Viewpoint 4 is a mid-range view looking west from the Pembrokeshire Coast Path. The site is predominantly screened by intervening vegetation. Small glimpses of the site may be possible from this viewpoint. Developments visual impact: no change / slight adverse impact

- 5.26 Photo Viewpoint 4 Once the proposed native buffer plantation is established (2-3 years) it is considered that the no change / slight adverse impact will be reduced to no change.

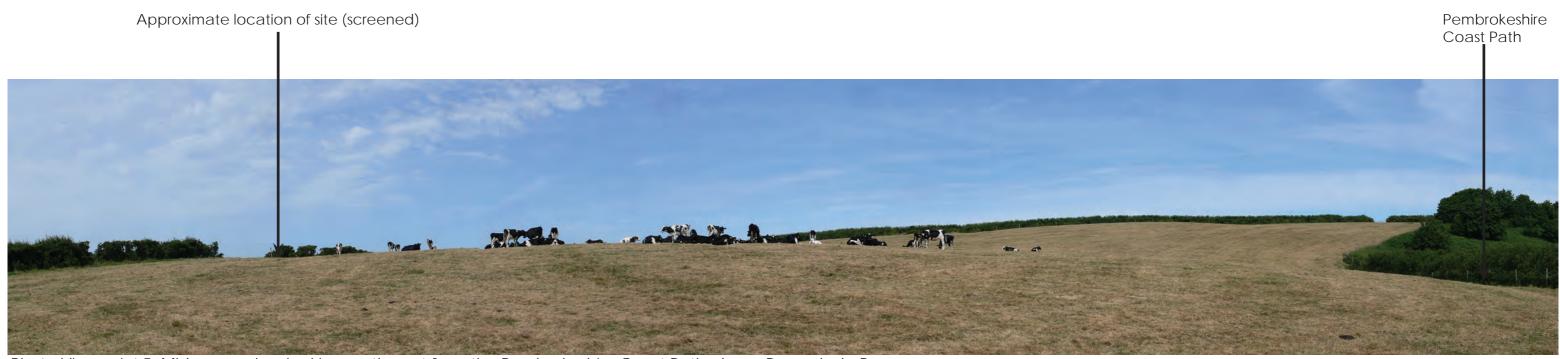
Photo Viewpoint 5: Mid-range view looking north west from the Pembrokeshire Coast Path above Brownslade Bay

- 5.13 Photo Viewpoint 5 is a mid-range view looking north west from the Pembrokeshire Coast Path above Brownslade Bay. The site is screened by intervening topography. Developments visual impact: no change

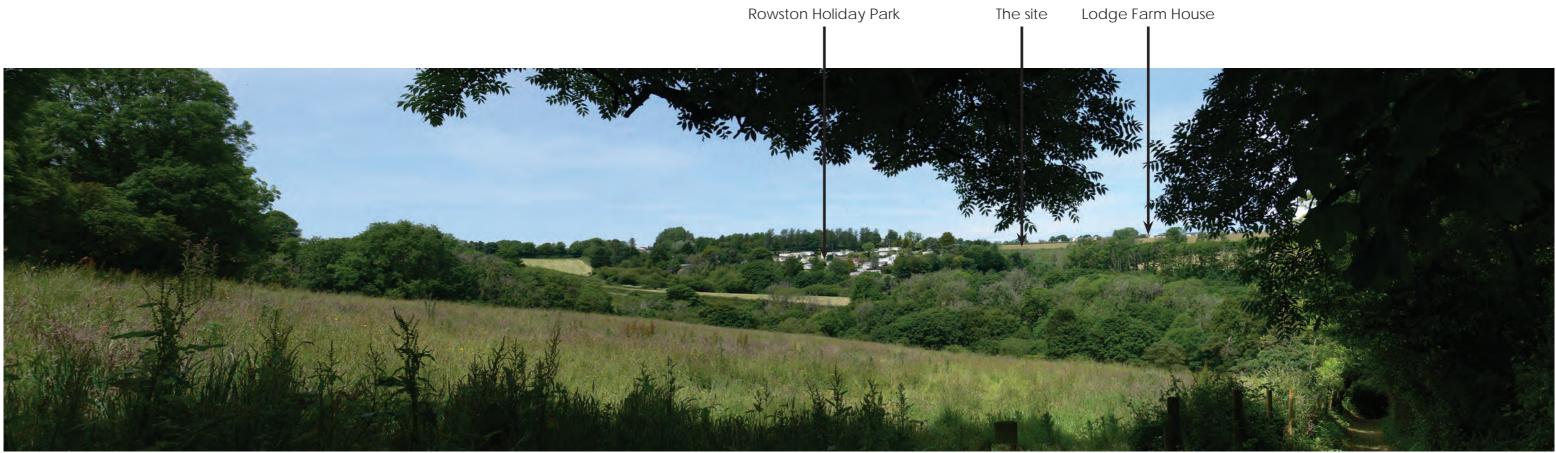
Photo Viewpoint 6: Mid-range view looking north from the Pembrokeshire Coast Path above Waterwynch Lane

The site (predominantly screened)

- 5.14 Photo Viewpoint 6 is a mid-range view looking north from the Pembrokeshire Coast Path above Waterwynch Lane. Sections of the site are visible from this viewpoint. Developments visual impact: slight adverse impact

- 5.27 Photo Viewpoint 6 Once the proposed native buffer plantation is established (2-3 years) it is considered that the slight adverse impact will be reduced to no change.

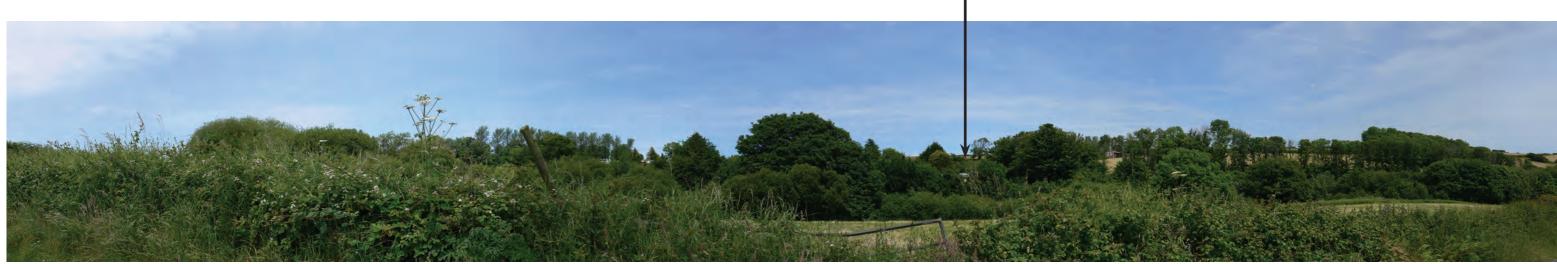
Photo Viewpoint 7: Short-range view looking north from Waterwynch Lane

- 5.15 Photo Viewpoint 7 is a short-range view looking north from Waterwynch Lane. The site is predominantly screened by intervening woodland. Glimpses of the site may be possible through the treeline.

Developments visual impact: slight adverse impact

- 5.28 **Photo Viewpoint 7 –** Once the proposed native buffer plantation is established (2-3 years) it is considered that the **slight adverse** impact will be reduced to **no change**.

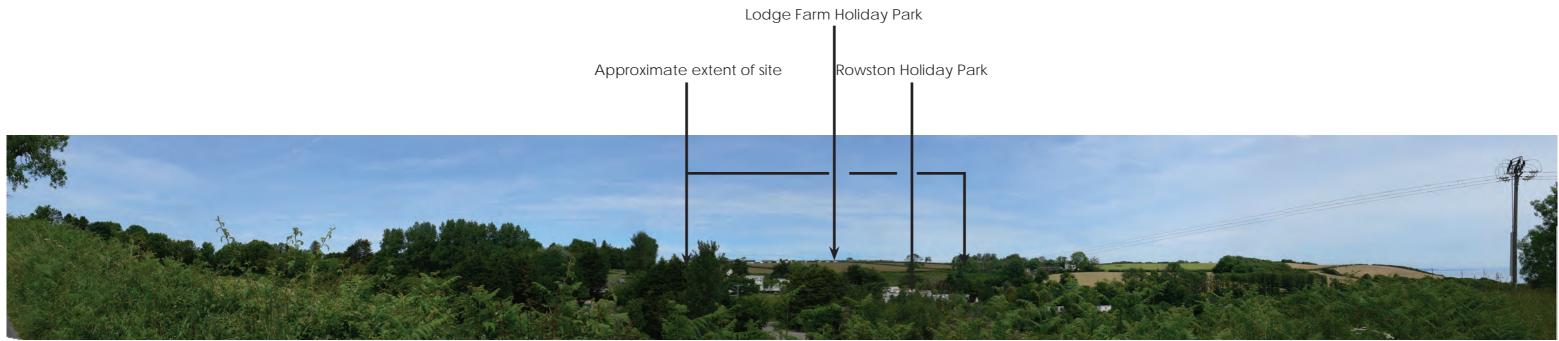
Photo Viewpoint 8: Mid-range view looking north from Waterwynch Lane

5.16 Photo Viewpoint 8 is a mid-range view looking north from Waterwynch Lane. Sections of the site are visible.

Developments visual impact: moderate adverse impact

- 5.29 Photo Viewpoint 8 Once the proposed native buffer plantation is established (2-3 years) it is considered that the **moderate adverse** impact will be reduced to **slight adverse** impact.

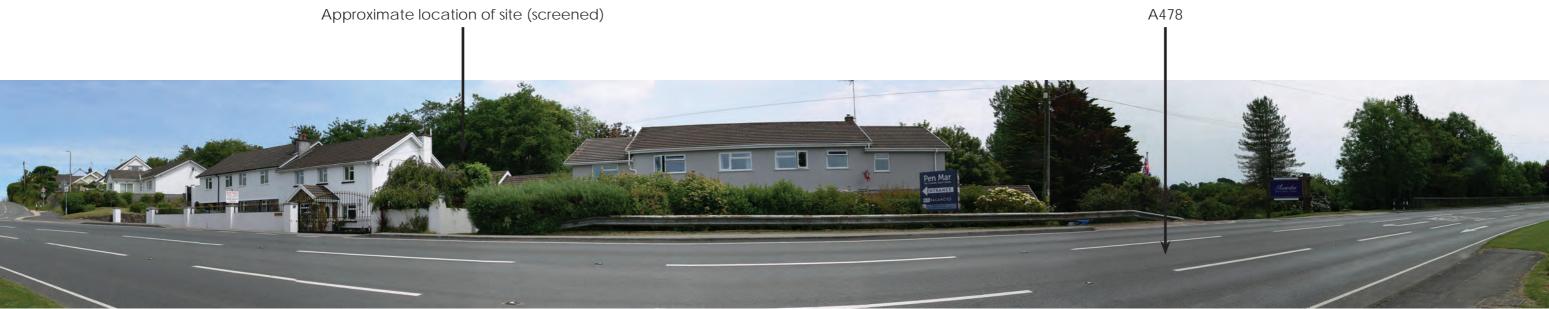
Photo Viewpoint 9: Short-range view looking east from the A478

- 5.178Photo Viewpoint 9 is a short-range view looking east from the A478. The site is screened by intervening residential properties. Developments visual impact: no change
- 5.18 Photo Viewpoint 10 is a short-range view looking east from the B4316. The site is screened by intervening roadside hedgerow. Developments visual impact: no change
- 5.19 Photo Viewpoint 11 is a mid-range view looking south from the unnamed road to Trevayne Campsite. The site is predominantly screened by intervening hedgerows and Lodge Farm Holiday Park Developments visual impact: slight adverse impact

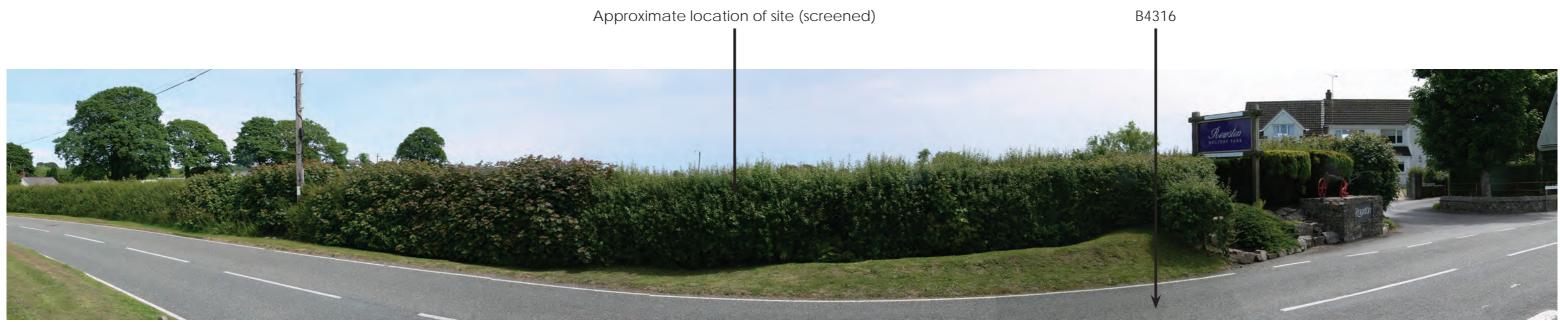
Photo Viewpoint 10: Short-range view looking east from the B4316

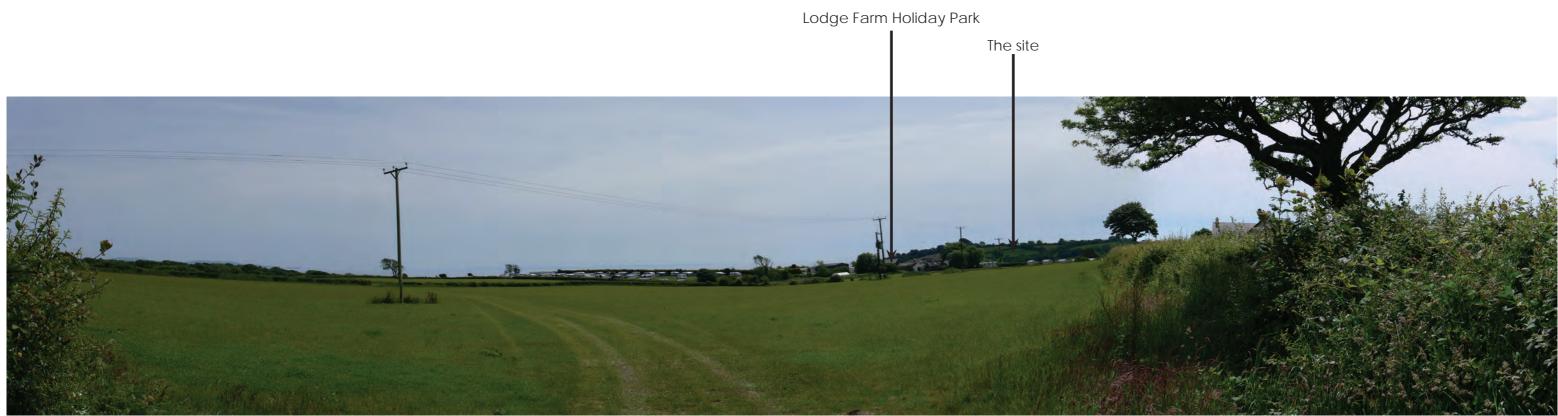
Photo Viewpoint 11: Mid-range view looking south from the unnamed road to Trevayne Camp-site

- 5.30 Photo Viewpoint 11 Once the proposed native buffer plantation is established (2-3 years) it is considered that the slight adverse impact will be reduced to no change.
