## **BAT ACTIVITY SURVEY**

Roch Gate (Former Motel), Roch, Haverfordwest, Pembrokeshire

**Report Reference – WW/Bats/170723**

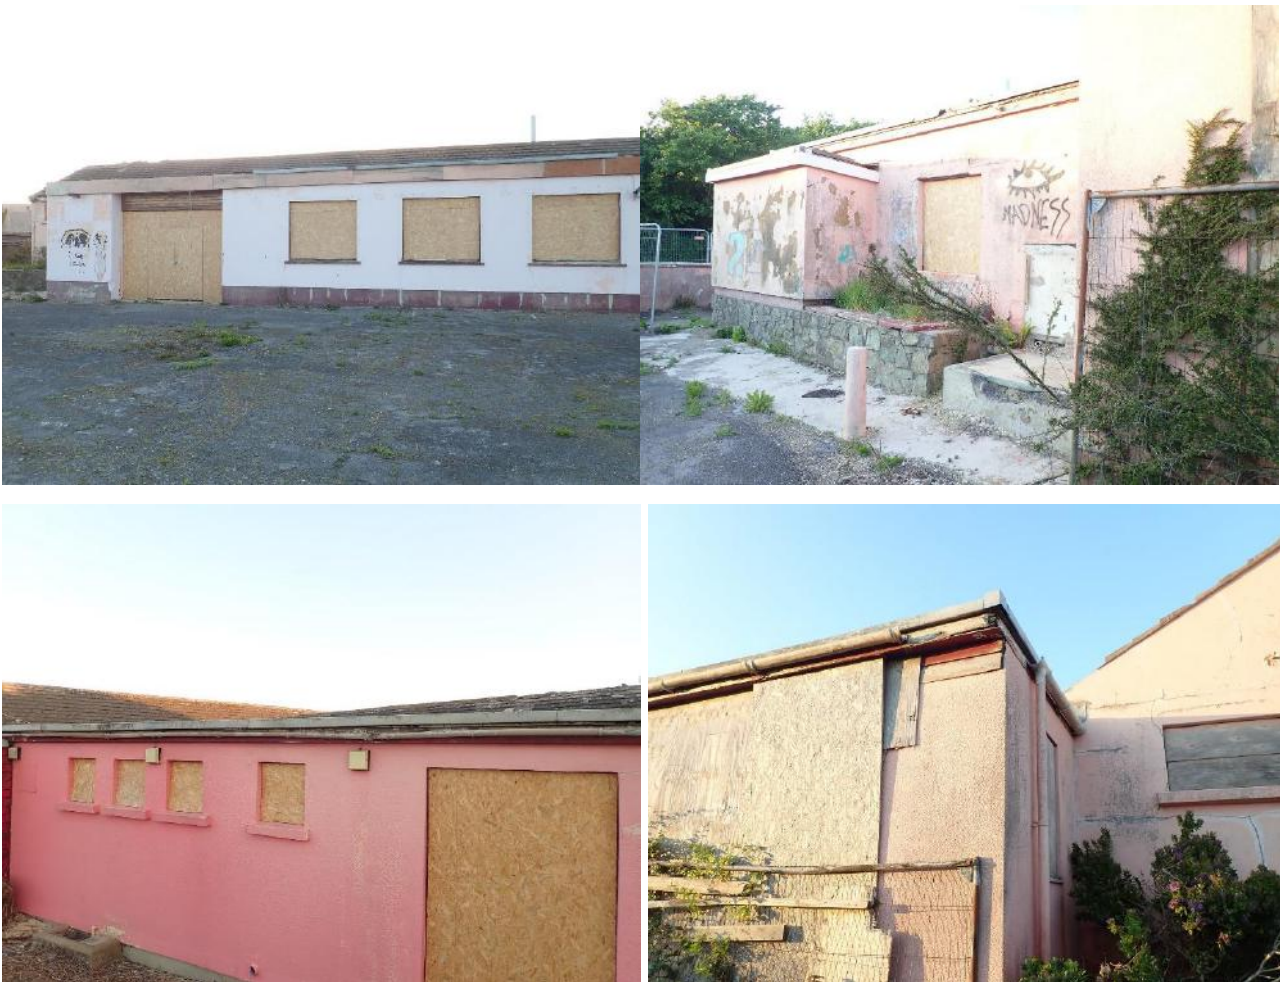
The buildings are in a very poor state of disrepair due to being unused for a number of years. Both buildings have painted smooth render; the paint is peeling in places but the render mainly remains intact. The western building has many window panes missing on the western elevation and the northern

The eastern building has boarded up windows and doors due to vandalism in the past. Access via soffit squeeze gaps is apparent. The northern section of this building has a flat roof and no roof void. The roofs are mainly intact.

*External photographs of eastern building (Clockwise from top left): Southern elevation with boarded up windows and doors, and mainly intact roof; western elevation with flat roof; potential squeeze gaps behind boarding and at corner of soffits; eastern elevation.*

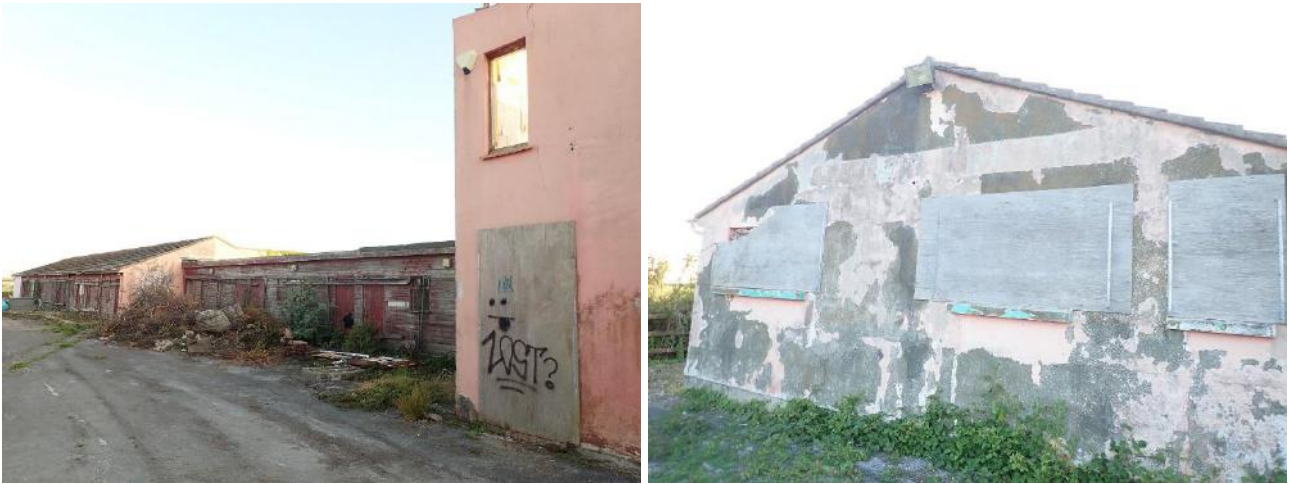
section of this building no longer has a roof, therefore much of this structure is open to the elements. The southern section has many ceilings missing, resulting in open access to the roof space.

*External photographs of western building: Eastern elevation (left) and (right) southern elevation with boarded up windows.*

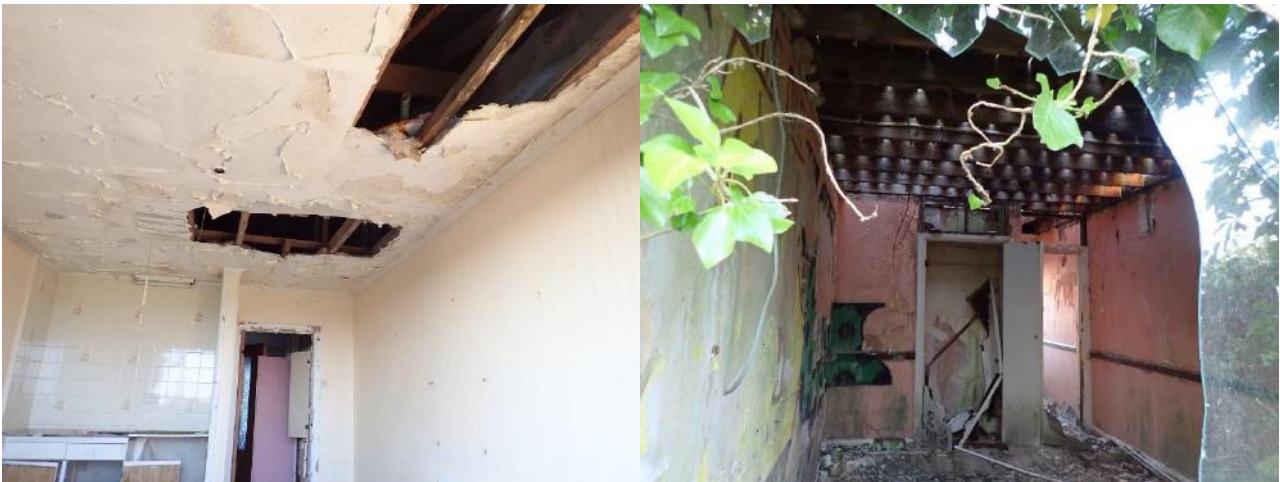
Internally, there was no access to either building due to health and safety concerns. However, the internal spaces of the western building could be viewed through broken windows. No cracks or crevices within the internal walls were apparent. Access was possible to the roof space via missing ceiling plasterboard and in some places whole sections of ceiling were missing, leaving joists exposed.

*Internal photographs of western building: Missing ceiling plasterboard (left) and (right) exposed joists and broken window.*
